Hasani et al. Journal of Medical Case Reports

Ureterovaginal fistula after hysterectomy with double-J stent misplacement into the inferior vena cava: a case report

(2025) 19:236

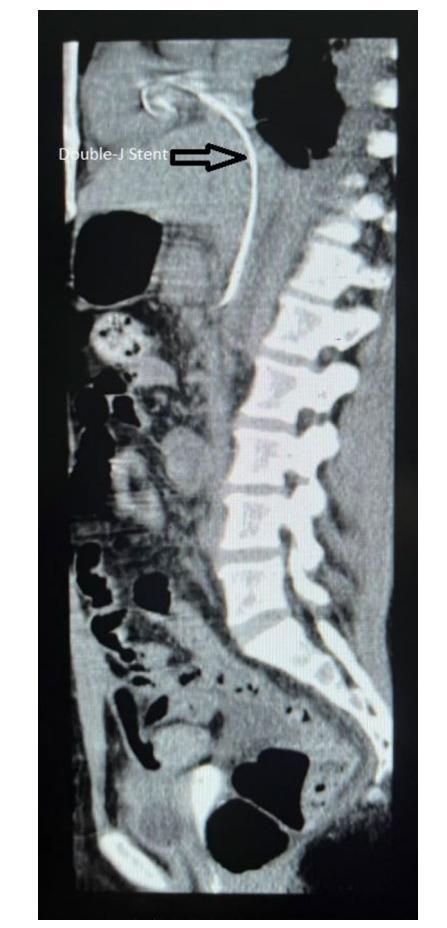
Fig. 1 Computed tomography of the abdomen/pelvis (sagittal slice) in the immediate postoperative period. Arrow indicates the proximal tip of the double-J stent located in the right atrium of the heart

Postoperatively, a computed tomography (CT) scan of the abdomen and pelvis revealed that the proximal end of the double-J stent was in the heart (Fig. 1). As shown in Fig. 2, the CT scan confirmed migration of the double-J stent into the suprarenal segment of the IVC, near the right atrium. An ultrasound examination was not performed at this stage but could have provided additional insights into stent positioning and served as an alternative diagnostic tool. The patient subsequently underwent laparotomy for removal of the stent and ureteral re-anastomosis to the bladder. The surgical team included a general surgeon and two urologists, with a vascular surgery team on standby for potential bleeding from the IVC.

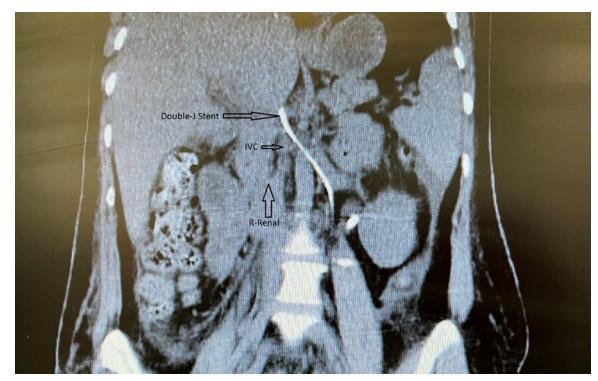
Fig. 2 Computed tomography of the abdomen/pelvis (coronal slice) in the preoperative period. Arrow indicates the course of the double-J stent extending from the left renal vein into the suprarenal segment of the inferior vena cava (IVC). Arrow 1: Shows the left renal vein. Arrow 2: Indicates the double-J stent misdirected into the inferior vena cava (IVC). Arrow 3: Points to the suprarenal segment of the IVC where the proximal end of the stent is located
